AFWAL-TR-87-4001

FAILURE ANALYSIS OF COMPOSITE STRUCTURE MATERIALS

May 1987

Final Report for Period of 1 October 1985 to 31 August 1986

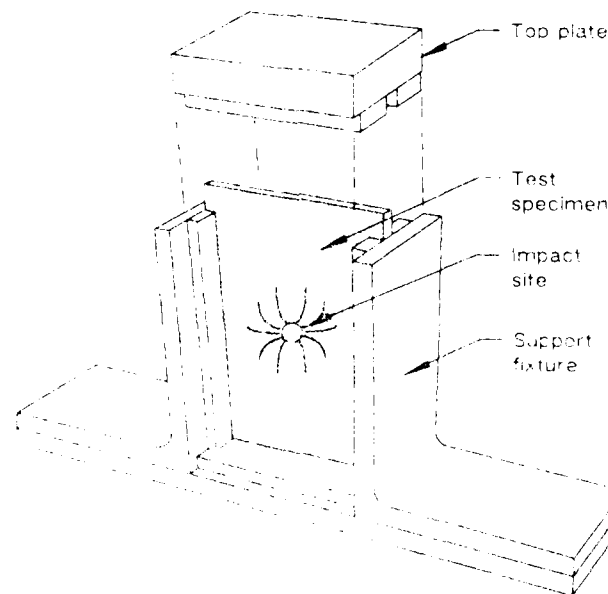
Compression testing was performed on 4- by 6-in quasi-isotropic laminates after impact testing. In order to provide visible surface damage and a critical level of internal damage, each specimen was impacted at 384 in-lbs at the approximate specimen center. Figure 6 illustrates the extent of internal damage generated as a result of impact testing. Compression failure after impact was produced by end loading the short dimension of the coupon, with edge fixity provided along all four sides by knife edge contact with a support jig (see figure 7). In general, buckling of these samples was observable at 80% to 90% of compression ultimate strength. However, fracture of the specimens typically occurred in a rapid and catastrophic manner, precluding visual identification of either the origin or direction of fracture during test.

Figure 7. Compression After Impact Test
Done With Specimen in Place

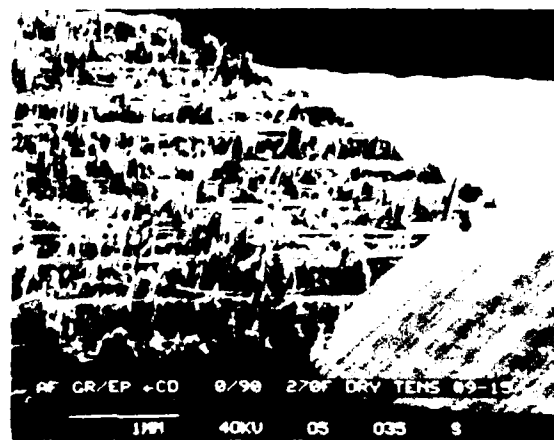
For translaminar tension failures, alterations in the temperature of fracture were found to generate changes in the amount of fiber pull out. As illustrated for the 0/90 layup in figure 10, fracture at -65°F was found to produce relatively dense bundles of 0-degree fiber fracture. Fiber breakage within these bundles tends to occur along the same approximate plane. As a result, individual fiber pull out for this failure environment is

Figure 10. Low Magnification SEM Fractographs Illustrating Variation in Fiber Pullout With Temperature for 0/90-deg Laminates

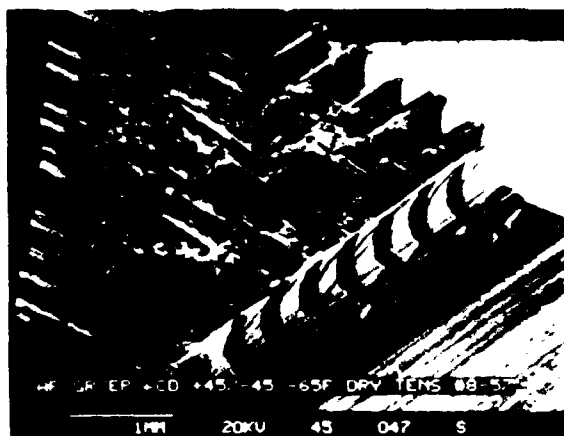
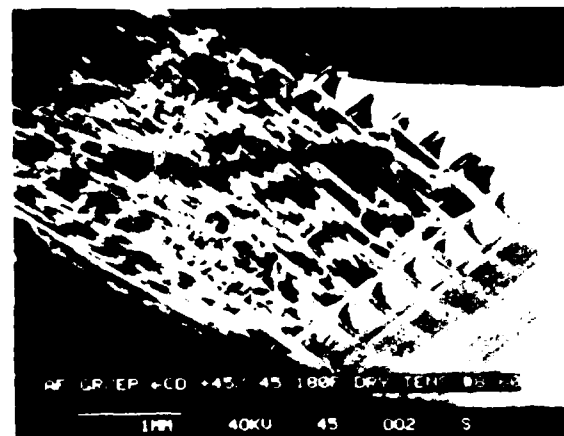
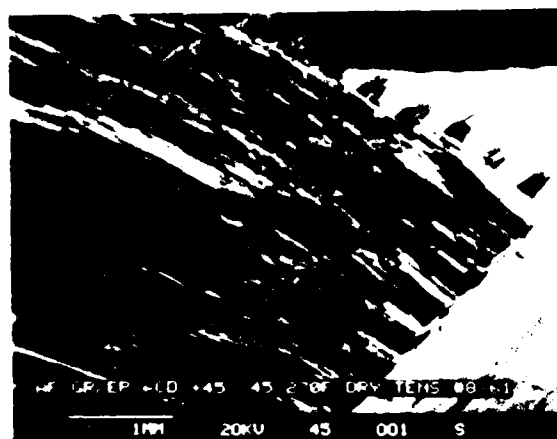
What is interesting is that these behaviors also appear to translate to 0/90 degree, +45/-45 degree (figure 11) and to a lesser extent, quasi-isotropic (figure 12) layups. This observation suggests that relative extremes in the environment prior to or during fracture may be identifiable for a variety of layups.

Figure 11. Low Magnification SEM Fractographs Illustrating Variation in Fiber Pullout With Temperature for +45/-45-deg Laminates

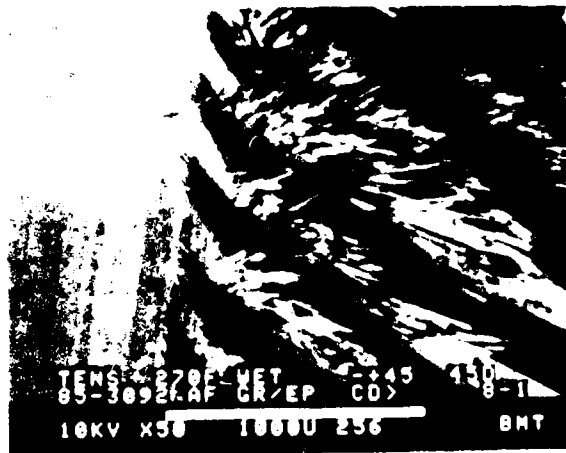
270°F wet

Figure 18. Low Magnification SEM Fractographs Illustrating Environmental Wet, +45/-45 Tensile Failures

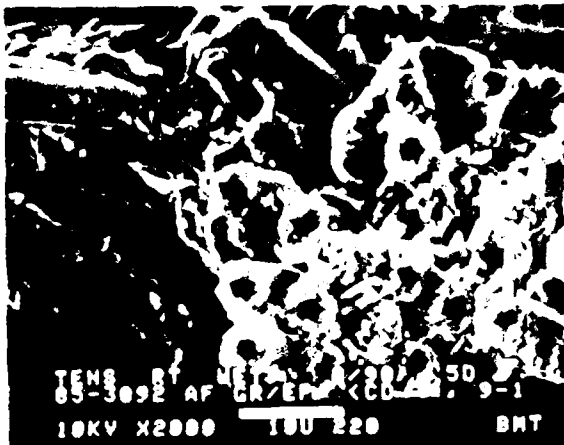
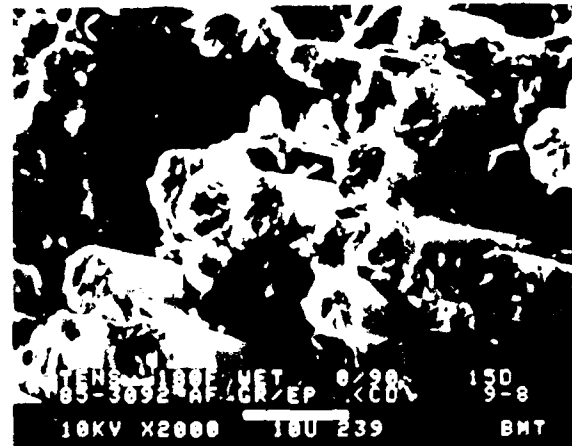
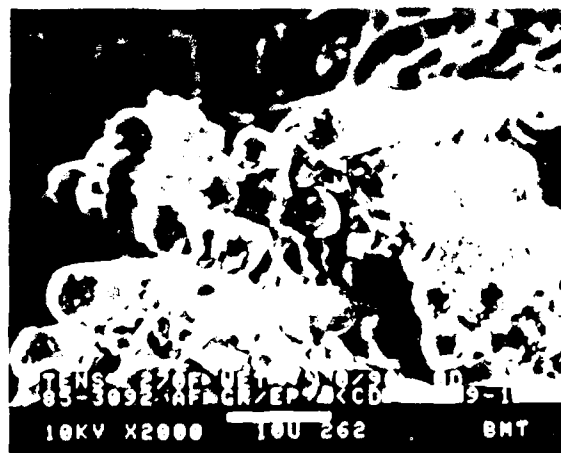
Figure 19 SEM Fractographs Illustrating the Direction of Individual Fiber Fractures for Environmental Wet 0/90 Tensile Failures

70°F, wet

180°F, wet

Mechanically induced crack direction

270°F, wet

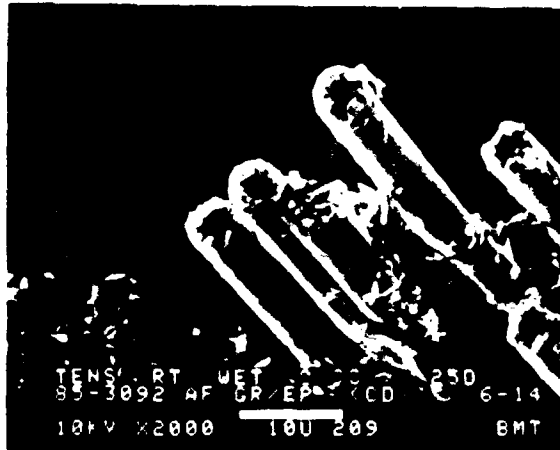
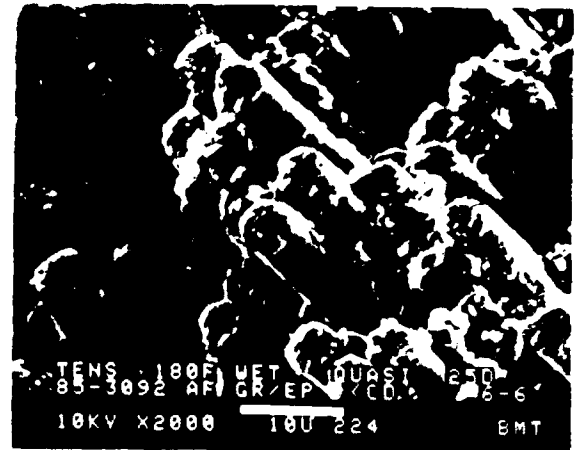
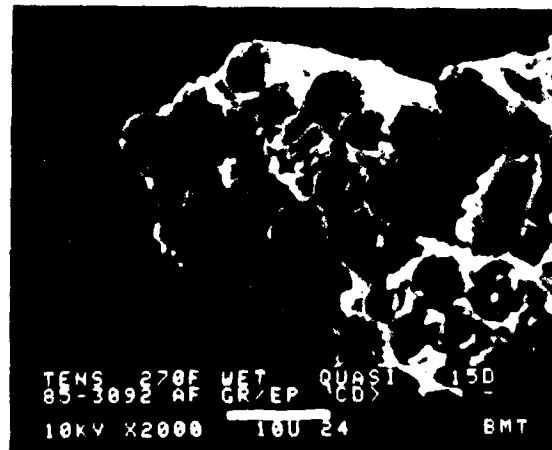
Figure 20. SEM Fractographs Illustrating the Direction of Individual Fiber Fractures for Environmental Wet, Quasi-Isotropic Tensile Failures

70°F. wet

180°F. wet

270°F. wet

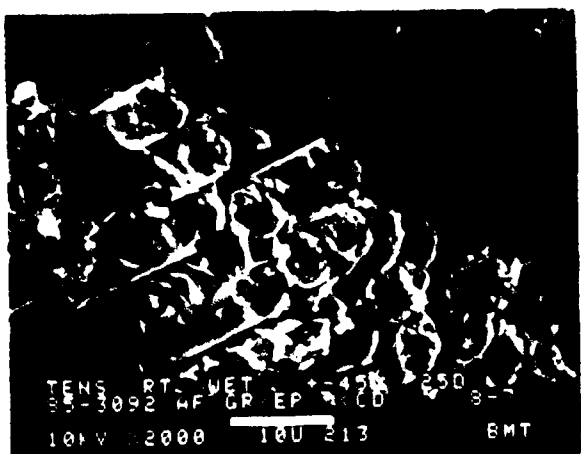
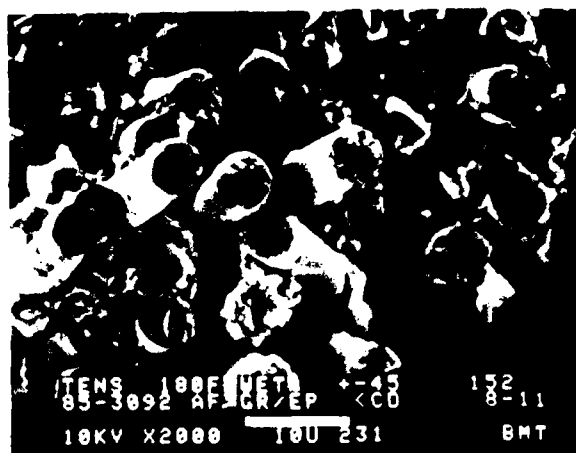
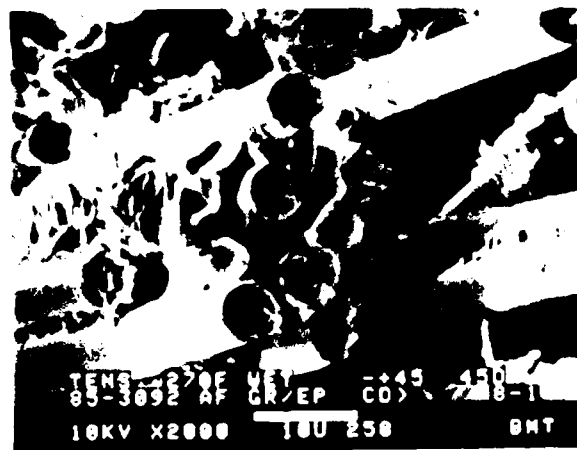
Figure 21. SEM Fractographs Illustrating the Direction of Individual Fiber Fractures for Environmental Wet, +45/-45, Tensile Failures

70°F. wet

180°F. wet

270°F. wet

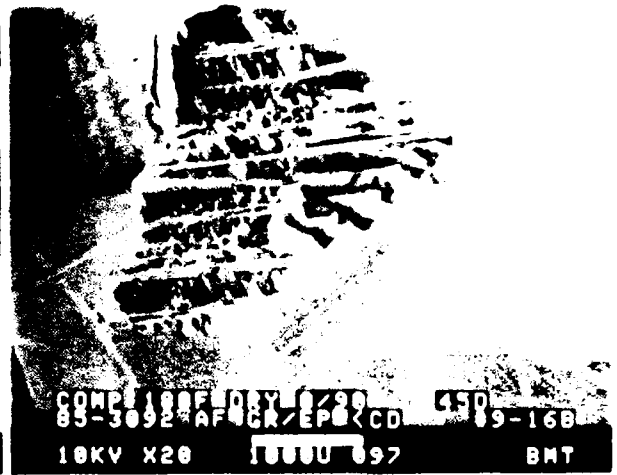
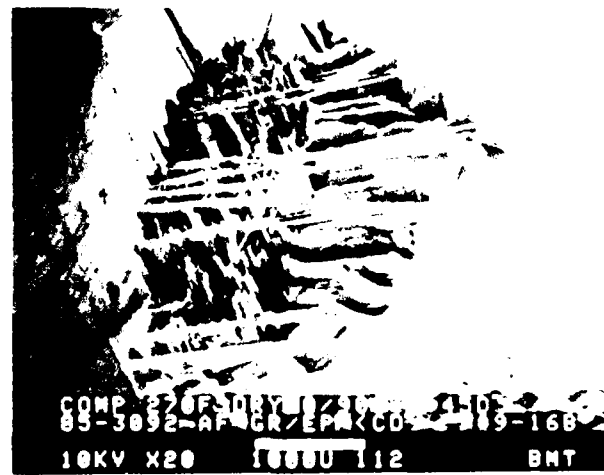
Figure 23. Low Magnification SEM Fractographs Illustrating Similar Appearances of Translaminar Compression Fracture at Different Temperatures for 0/90-deg Laminates

For translaminar compression fractures, failure under different temperature and absorbed moisture conditions was not found to produce any pronounced changes in fracture morphology. At low magnification each of the layups examined revealed a basic morphology consisting of distinct areas of tensile and compressive failure (see figures 22 through 25). Areas of compression fracture exhibited a flat, crushed morphology sharply contrasting the fibrous appearance of tensile fracture areas located near the end of this flexurally loaded specimen. As shown in these figures, variations in failure temperature from -65°F (-54°C) to 270°F (132°C) increased the relative size of compression fracture area but did not alter this basic morphology.

-65°F, dry

180°F, dry

270°F, dry

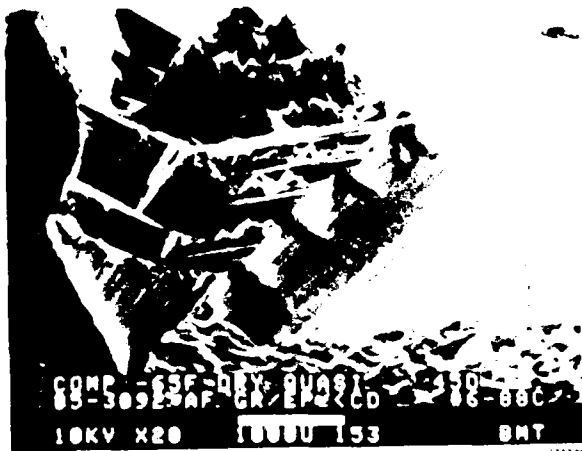
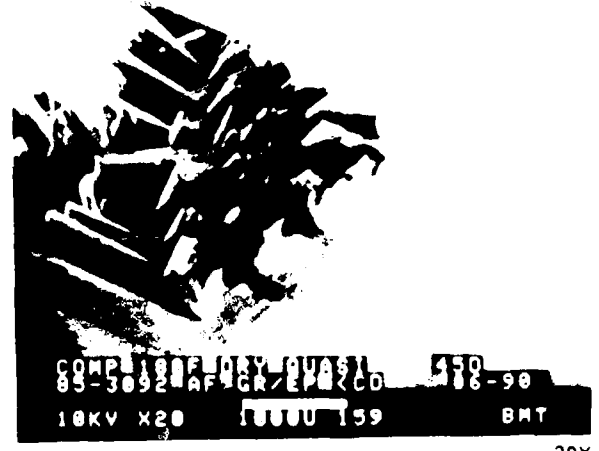
Figure 24 Low Magnification SEM Fractographs Illustrating Similar Appearances of Translaminar Compression Fracture at Different Temperatures for Quasi-Isotropic Laminates

-65°F. dry

180°F. dry

270°F. dry

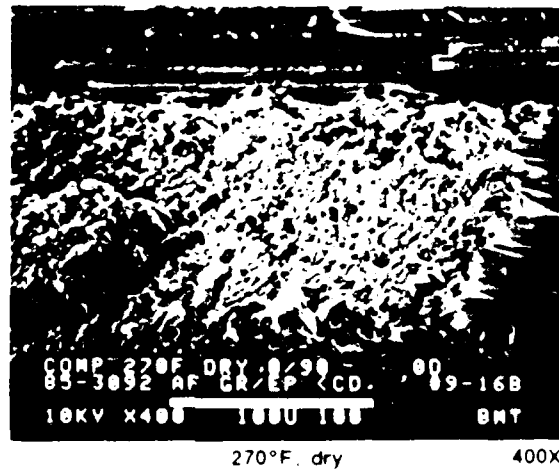
Figure 27 SEM Fractographs Illustrating Similar Appearances of Translaminar Compression Fracture at Different Temperatures for 0/90-deg Laminates

These specimens were tested under various temperatures (-65° to 270°F), but were in the dry, as fabricated, state. Examination of environmental dry compression fractures at higher magnifications (see figures 26 through 29) revealed similar behaviors to that noted at low magnifications. In general, close inspection revealed that fracture occurs in a planar manner with groups of fibers failing under microbuckling induced flexure. One exception of note, however, is quasi-isotropic laminates failed at -65°F . As illustrated in figures 24 and 28 failure of this laminate produced very little compression fracture area. Usually the majority of fractures occurred by secondary tensile failure. As illustrated in figure 28 penetration of this secondary fracture into the compression loaded crack tip produced zones exhibiting both tensile and compressive fracture characteristics.

-65°F, dry

180°F, dry

270°F, dry

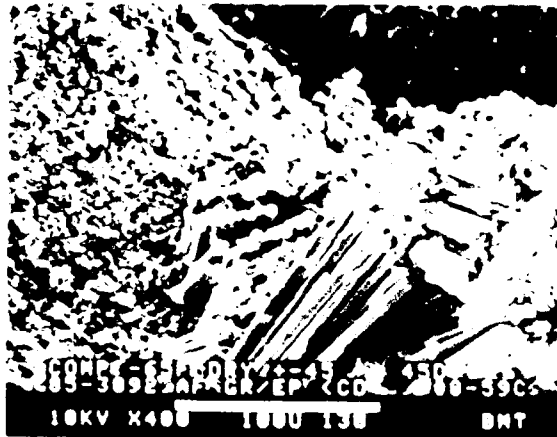
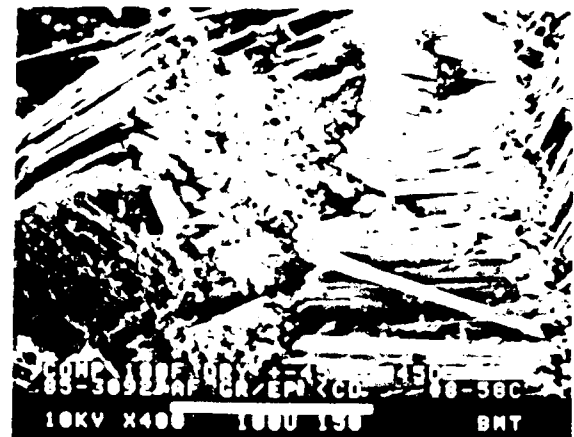
Figure 29. SEM Fractographs Illustrating Similar Appearances of Translaminar Compression Fracture at Different Temperatures for +45/-45-deg Laminates

The above results indicate that, while the overall mode of failure may be identifiable, no specific features exist indicative of either the environment or direction of crack propagation. While this finding suggests translaminar compression fractures to be relatively intractable, it is worthwhile to remember that significant amounts of delamination commonly accompany translaminar compression failures. As demonstrated in the interim report, these failure modes can often be analyzed with fairly good success.

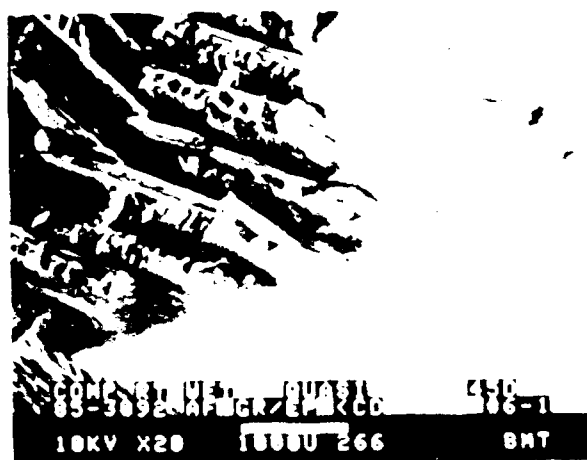
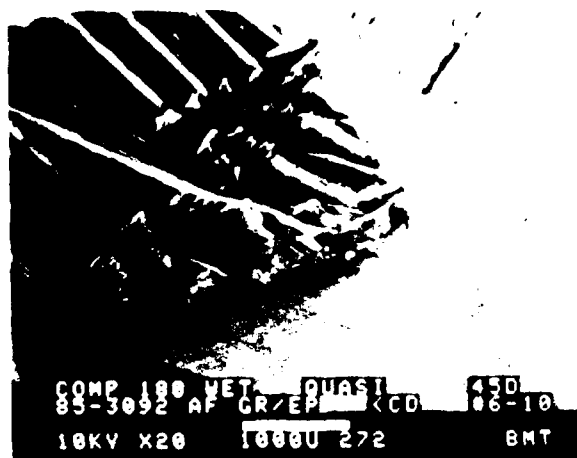
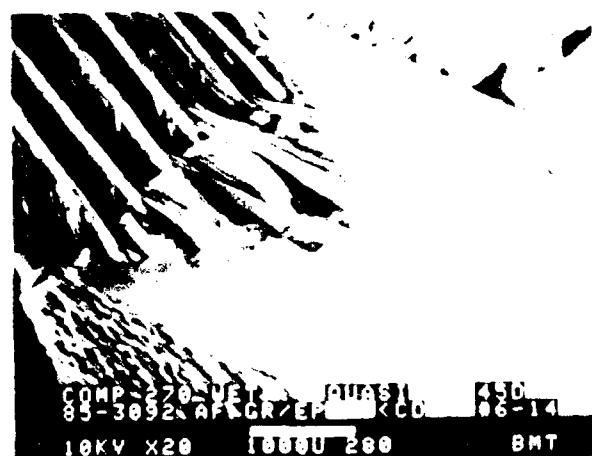
Figure 31 Low Magnification Fractographs of Quasi-Isotropic Laminate Compression Failures Produced at 70°F, 180°F, and 270°F, Wet

At an immediately obvious level of detail, failure occurred in the notch area by compression followed by a distinct transition into tensile failure (see figures 30 through 33). At this level of inspection, increasing test temperature can be seen to produce enlargement of the compressive failure zone as well as more distinct fiber pull out in areas of tensile separation. This alteration in compression failure zone size probably reflects the decreased compression stability of the notched region due to lowering of the matrix modulus with increasing temperature. Based on this behavior, the size of compression failure would also be expected to increase with moisture absorption. However, in comparing the appearance of wet versus dry specimens (see previous paragraphs), no differences in the size of compression failure can be distinguished. Given the pronounced effects of temperature visible in figures 30 through 33, this finding tends to suggest that matrix modulus reductions due to moisture are less than those produced by increasing temperature.

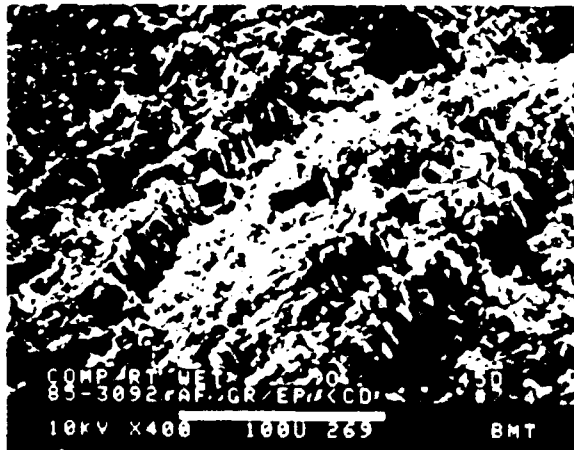
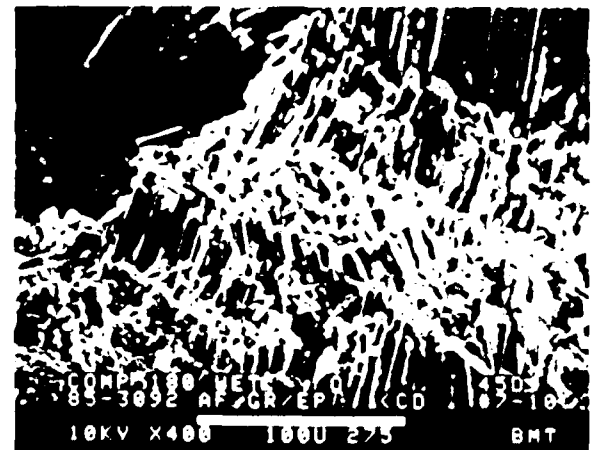
At higher magnification, failure by compression can be seen to produce a distinctly flattened topography. As depicted in figures 34 through 37, fiber failure appears to occur by axial microbuckling as evidenced by the extensive amounts of fiber kinking. Surface damage generated by the compression event, however, generally precludes the

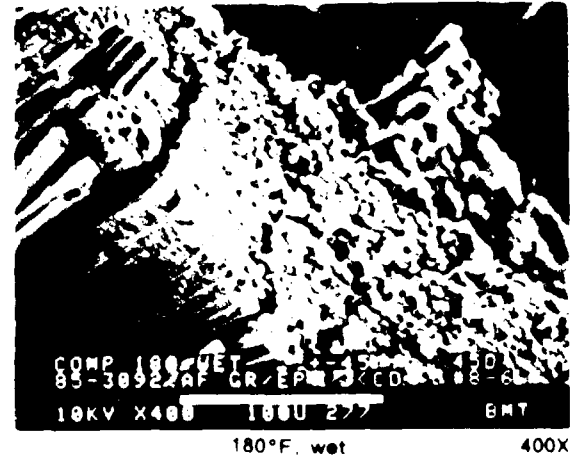
Figure 37 SEM Fractographs of +45/-45 deg Laminate Compression Failures
Produced at 70°F, 180°F, and 270°F Wet

recognition of details at any finer level. These observations are consistent with those previously reported for specimens failed without absorbed moisture. In comparing failure modes at this level, no difference in failure mode is recognizable due to absorbed moisture.

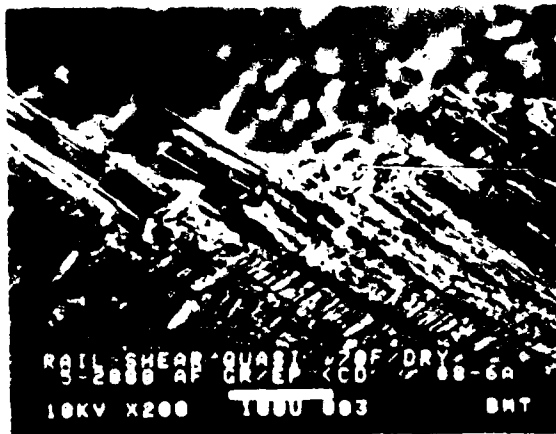
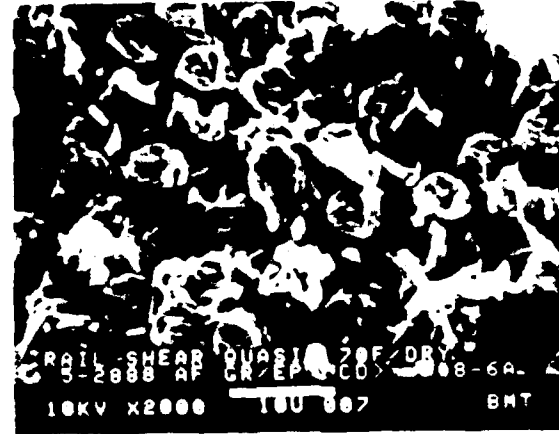
Figure 38 SEM Fractographs Illustrating Morphology of 70°F Dry 0/90 deg
Laminate Rail Shear Failure

General topography exhibits features characteristic of both compression and flexural fiber failure

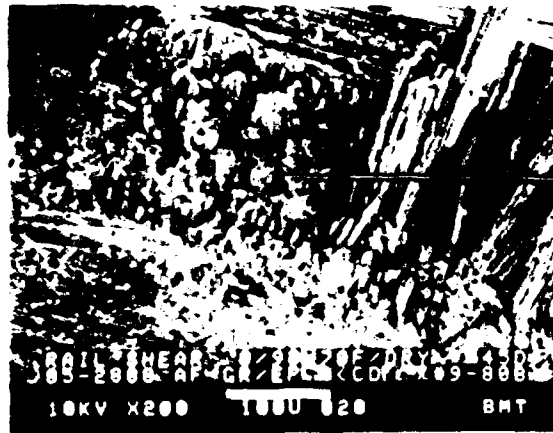
Figure 39 SEM Fractographs Illustrating Morphology of 70°F Dry Quasi-Isotropic Laminate Rail Shear Failure

General topography exhibits features characteristic of both compression and flexural fiber failure

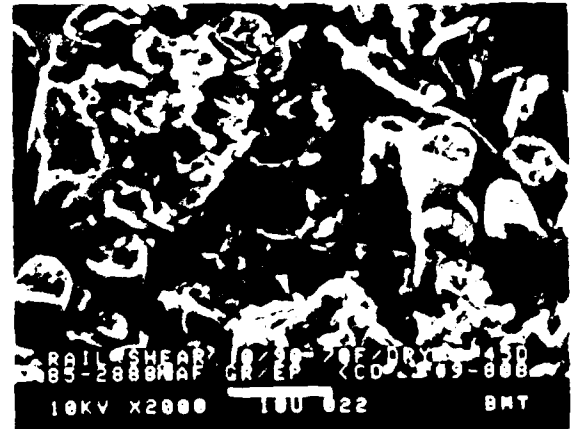
The presence of both shear and compression loads at failure were discernable in the fracture morphology exhibited by both quasi-isotropic and 0/90 laminate specimens. Figures 38 and 39 illustrate the fracture features characteristic of each laminate. In general, the overall fracture topography exhibited compression surface damage with occasional areas of pulled out fibers. In comparison, this topography tended to be more irregular than that characteristic of Mode I translaminar compression. Closer inspection revealed individual fiber fracture occurred by fiber microbuckling, as in compression. In observing a large number of areas, no correspondence of the direction of microbuckle failure and the induced crack direction was apparent. However, as shown in figure 38, conditions of extensive fiber-matrix separation in the lateral direction were prevalent in many locations with individual fibers spread apart from one another. Lateral separation of these fibers probably occurs in response to resolved and lateral tensile stresses developed as a result of shear displacement.

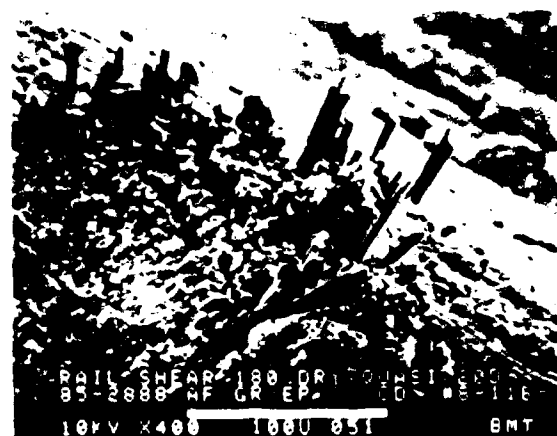
Figure 4. Low Magnification Fractographs Illustrating Morphology of Quasi-Isotropic [0.45.90] 16S Shear Failures Produced at 65°F, 180°F, and 270°F Dry.

As illustrated in figures 40 through 47, translaminar failures produced under shear did not exhibit any pronounced sensitivity to either environment or absorbed moisture. Figures 40 through 43 illustrate the gross fracture topography of specimens failed at 270°F wet and dry, 180°F wet and dry, 70°F wet and -65°F dry. For each

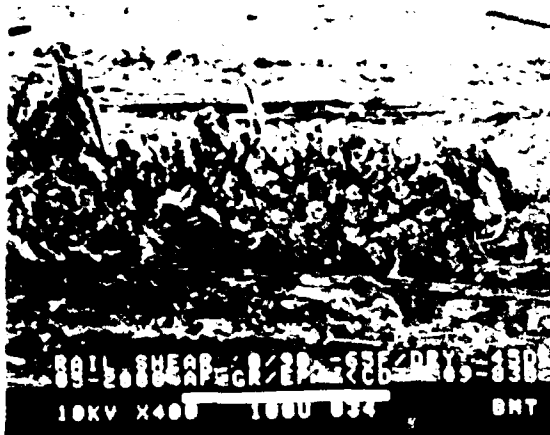
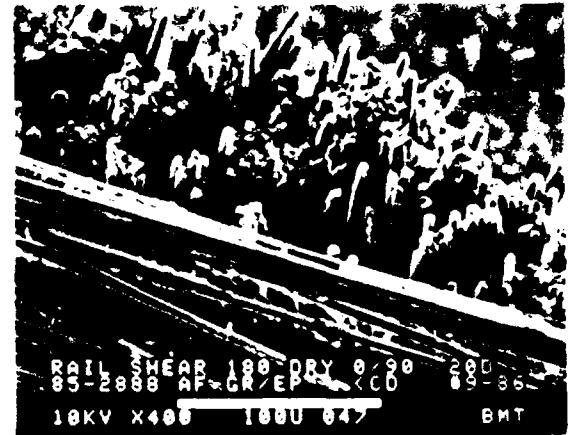
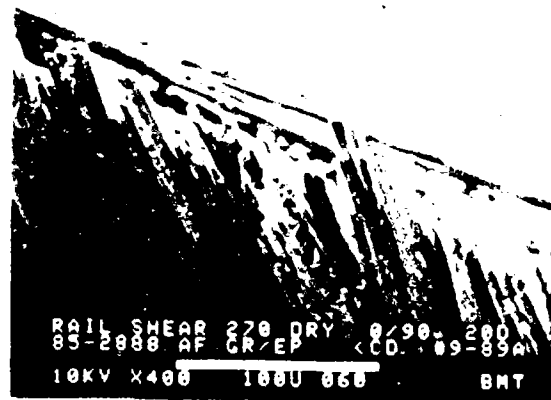
Figure 41 Low Magnification Fractographs Illustrating Morphology of 0/90-deg Rail Shear Failures Produced at -65°F, 180°F, and 270°F, Dry

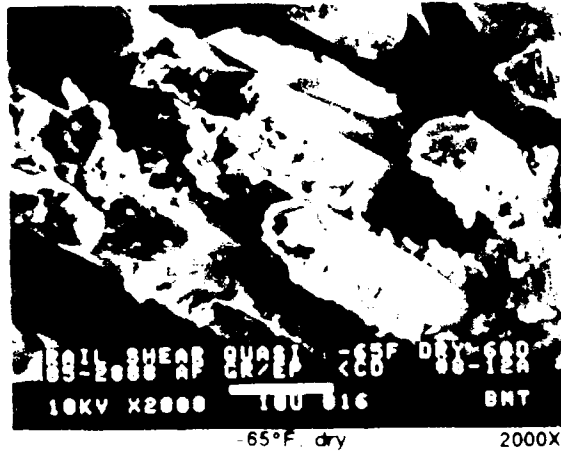
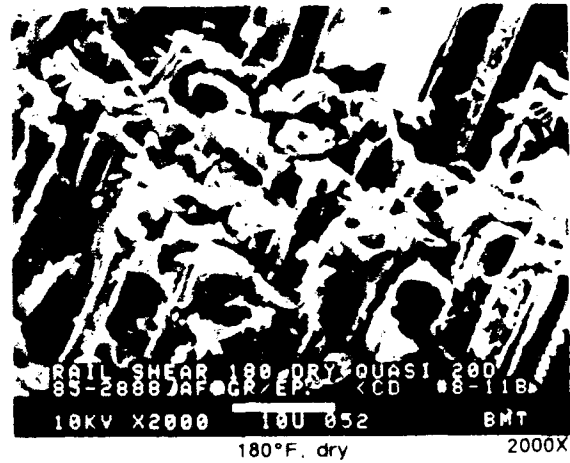
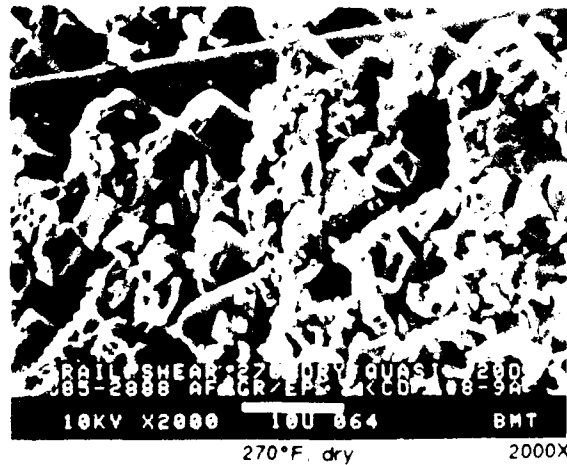
Figure 44 Detailed Fracture Characteristics of Quasi-Isotropic Rail Shear Laminates Failed at -65°F, 180°F, and 270°F Dry

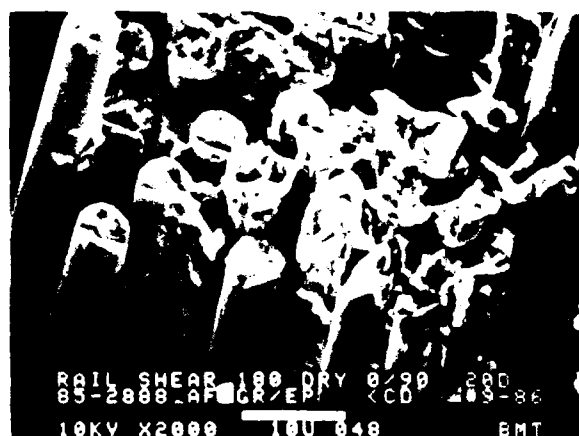
Figure 45. Detailed Fracture Characteristics of 0/90-deg Rail Shear Laminates Failed at -65°F, 180°F, and 270°F, Dry

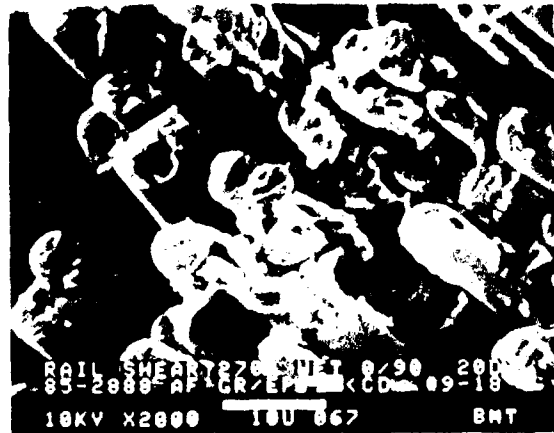
Figure 4.7 Detailed Fracture Surface Characteristics of 0/90-deg Rail Shear Laminates Failed at 70°F, 180°F and 270°F, Wet

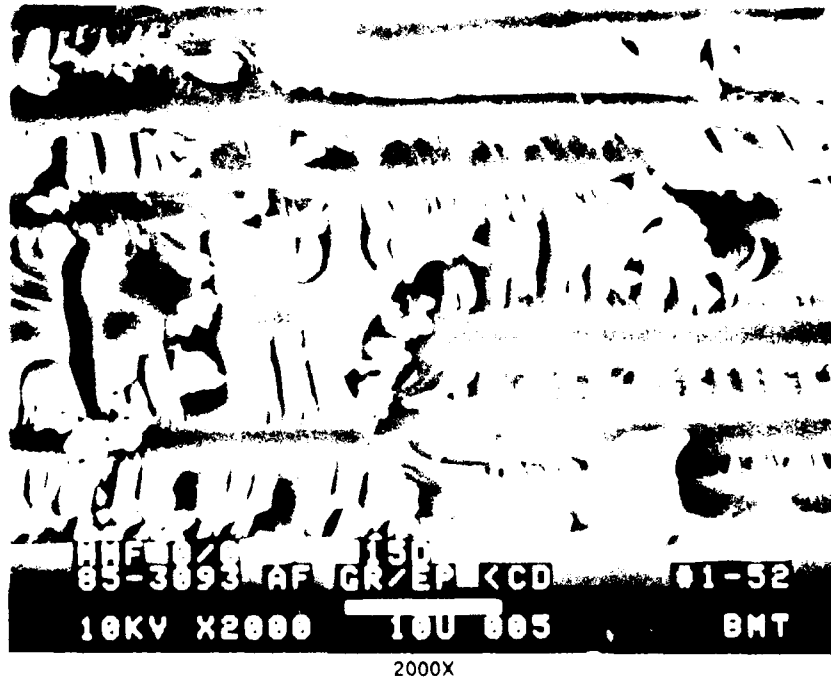
Note: Hackles and scallops formed by mechanisms A and B are illustrated.

Figure 48. Mixed Mode Fracture Morphology for 0-deg Laminate

Figures 48 through 51 illustrate the characteristic features of interlaminar failures produced under mixed mode loading. In general, the dominant morphology generated is that characteristic of Mode II shear. For a failure between adjacent 0-degree plies a relatively even mixture of hackles and scallops was observed (figure 48). With reference to earlier studies of pure Mode II failures, relatively little difference appears to exist. Hackle separation (for this interfacial failure condition) occurs by both mechanisms A and B, with the hackle platelets tilted parallel to the direction of induced propagation. This means that the hackle platelets can be tilted with, or opposite to, the direction of crack growth.

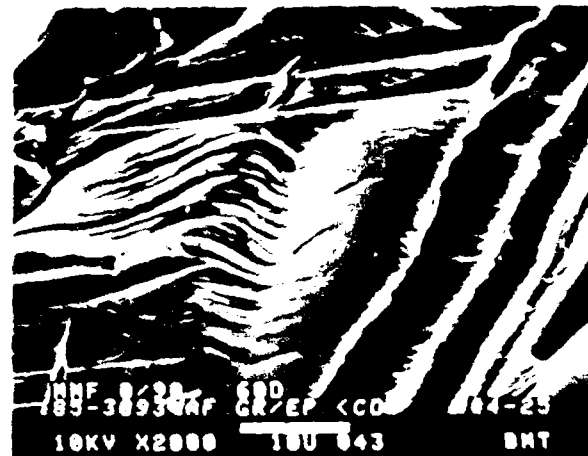
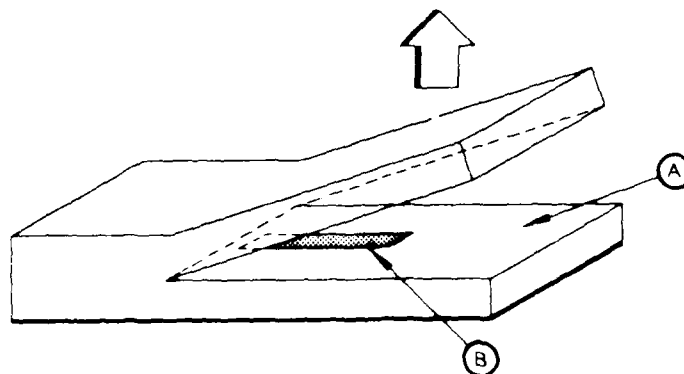
Note: Area A exhibited hackles formed by mechanism B, whereas area B exhibited river marks oriented coincident with, as well as opposite to, the induced direction of propagation.

Figure 49. SEM Fractographs Illustrating Mixed Mode Fracture of 0/90-deg Laminate

Mixed mode separation for several of the other crossply orientations (0/90 and 0/45) produced an interesting mixture of Mode II and Mode I fracture areas. The majority of separation occurred predominantly by Mode II fracture (see figures 49 and 50). Consistent with the 0-degree laminate specimen the overall morphology of these hackles exhibited no difference from that described previously for pure Mode II induced delaminations. With the exception of the 0/90 laminate, hackle separation for both 0/45 and +45/-45 laminates occurred predominantly by mechanism A (figures 50 and 51). Hackle separation for the 0/90 laminate occurred by mechanism B. These results

As indicated in figures 49 and 50, several areas of Mode I fracture were evident on each specimen. Typically, this morphology occurred in those areas where groups of fibers have been pulled from the main fracture plane. These areas of Mode I fracture exhibited river marks oriented both coincident with, as well as opposite to, the direction of crack propagation (see figure 49). This basic behavior appears to be understandable based upon how these areas of fracture are formed. As indicated earlier, these areas correspond to regions of fiber pull out. As schematically illustrated in figure 52, areas of pull out occur when local crack divergence produces fiber bridging across the crack tip. Under continued opening displacement such bridged areas can extend areas of delamination both toward, as well as away from, the direction of crack propagation. In terms of carrying out a failure analysis, this behavior can generate spurious directions of crack growth. However, examining a large number of fracture areas by optical microscopy should provide a means of averaging out such spurious areas and identifying the general direction of crack growth.

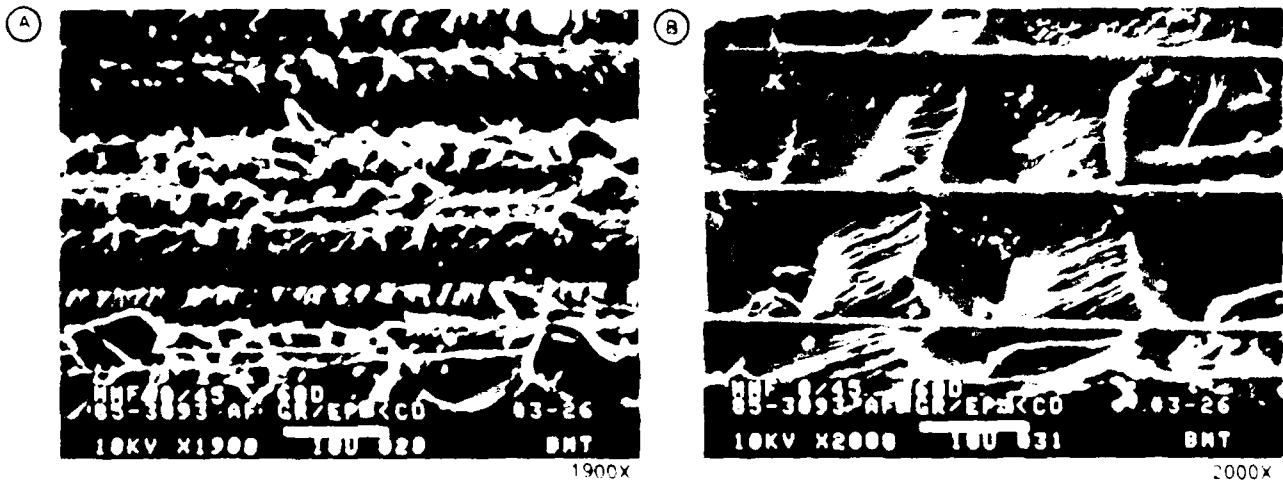
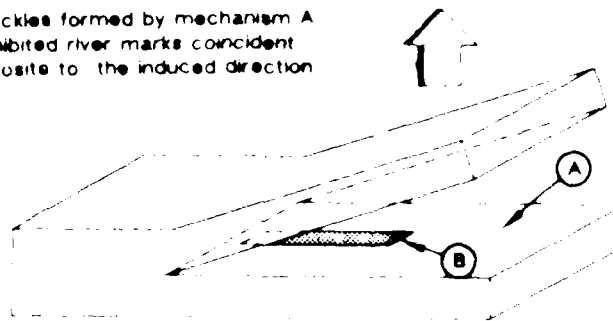
Note: Area A exhibited hackles formed by mechanism A whereas area B exhibited river marks coincident with, as well as opposite to, the induced direction of propagation.

Figure 50 SEM Fractographs Illustrating Mixed Mode Fracture of 0/45-deg Laminate

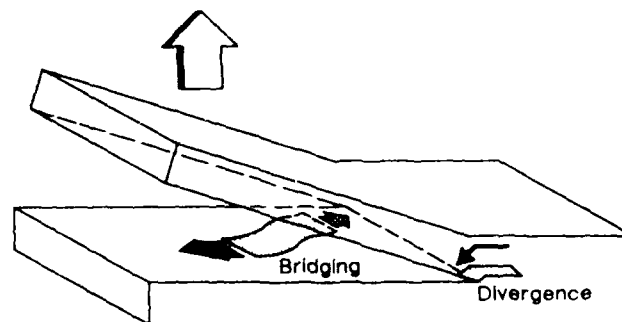
Figure 52. Schematic Showing Formation of Reverse Crack Directions Because of Out-of-Plane Crack Divergence and Subsequent Crack Tip Bridging

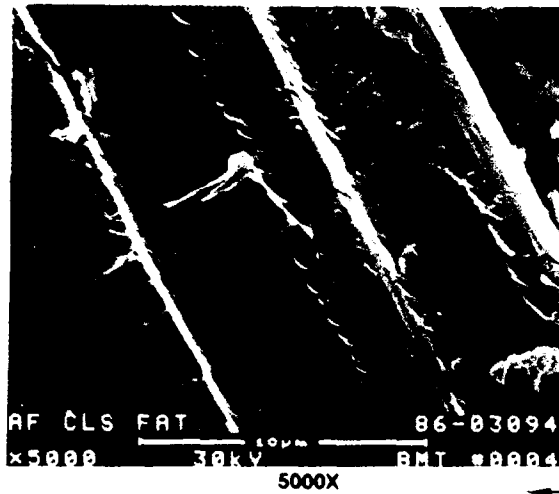
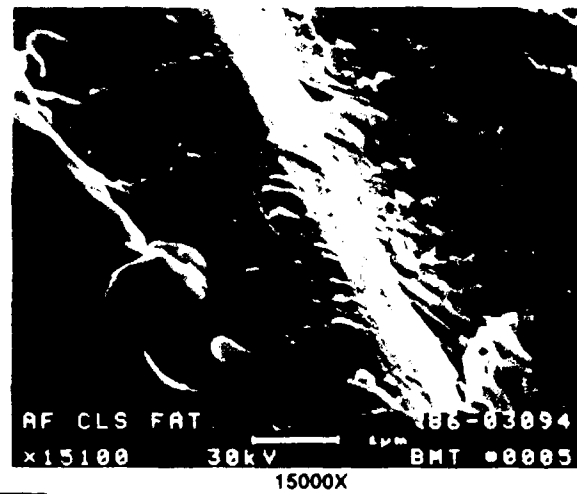
Cyclic loading ranged from 60% to 20% maximum static fracture stroke.

Figure 54. SEM Photomicrographs of Typical Fatigue Striation Formation of Mode II CLS Specimen

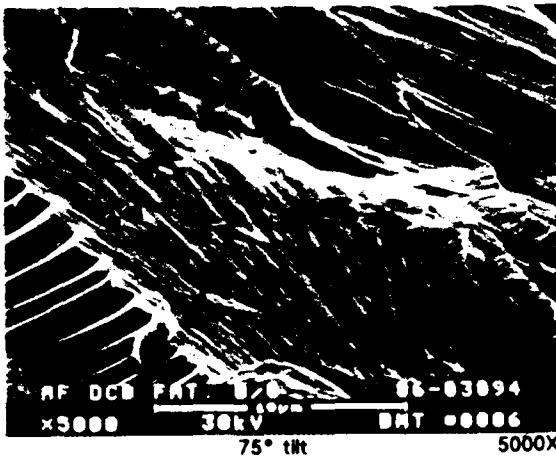
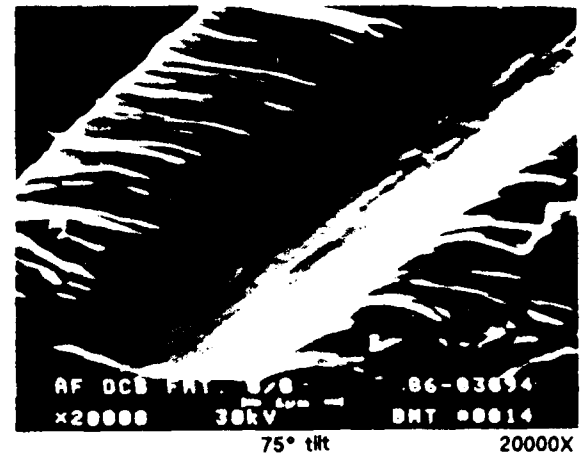
Figure 55. High Magnification SEM Photomicrographs of Regions That Exhibit Faint Striations

The left photo is in the resin fracture region, while the right photo presents the fiber-matrix interface region.

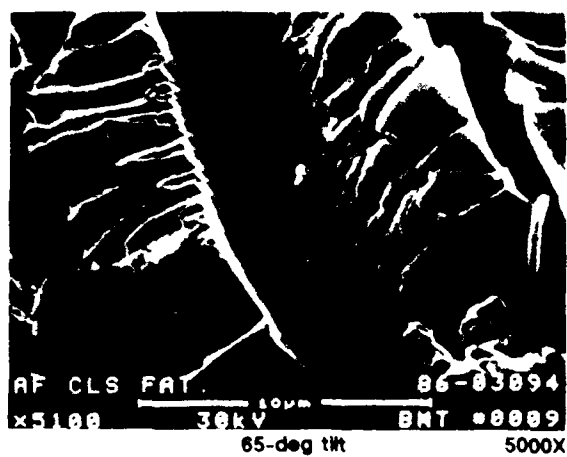
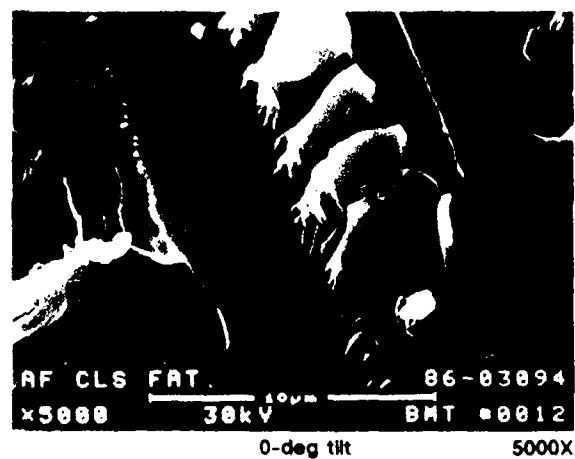
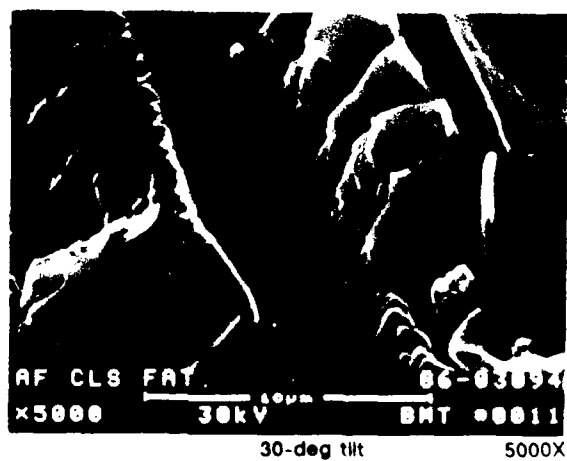
Figure 59. SEM Photomicrographs of Effect of Tilt on Striation Resolution

Figure 59 presents a comparison of a single field at 0-, 30-, and 65-degree tilts. Note that the striations are not resolvable or high enough contrast to identify in the 0- and 30-degree tilts.

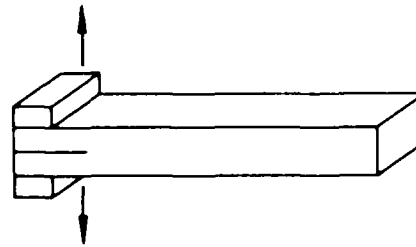
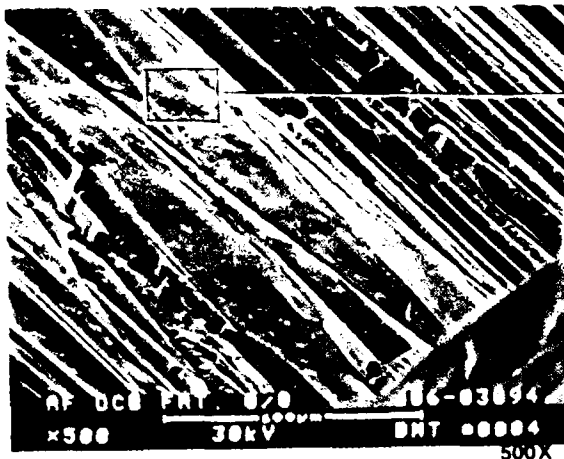
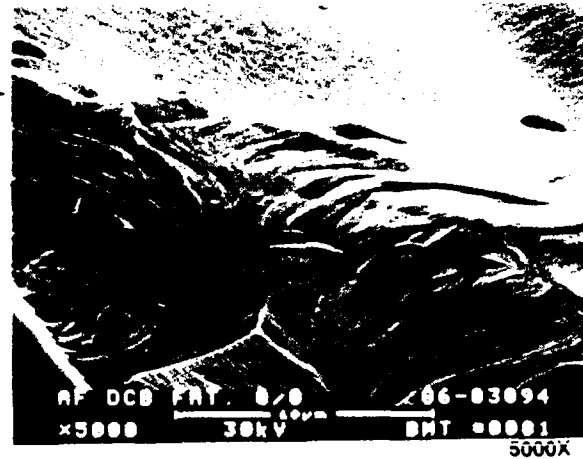
Figure 60. SEM Photomicrographs of Effect of Tilt on Striation Resolution (500X and 5000X)

Optical microscopy did not identify striations in the lower amplitude fatigue cycle region (20% to 60% maximum). SEM analysis using high tilts and optimum specimen rotation resulted in identification of striations which were much finer and closer spaced than those found in the high amplitude region (40% to 80% maximum). Additionally, these striations were very inconsistent in spacing. As with metals, this observation suggests fatigue crack growth is at, or very near, the threshold of striation formation. At low stress intensities of the crack tip, slight variations in localized loading (due to the load shedding nature of the fibers) can cause inconsistent crack front behavior as illustrated in figure 60.

Note smooth fracture topography and faint striations in right photo.

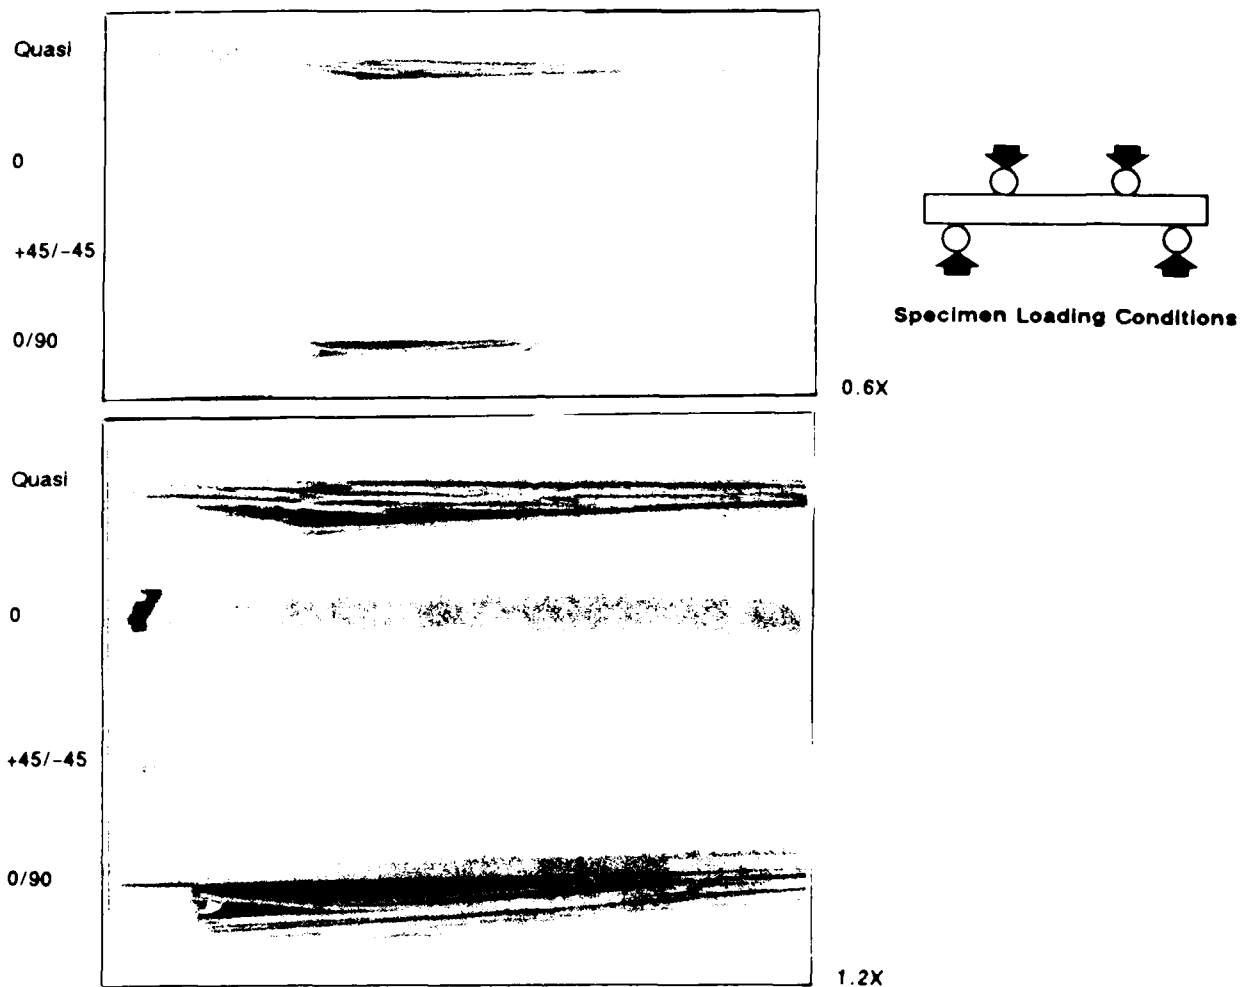
Figure 62. Overall Macrographs of Laminate Flexure Specimens

Specimens failed under laminate flexure proved interesting in that pronounced differences in failure mode occurred for each specimen layup. Figure 62 illustrates each of these failure modes. As shown, failure of the 0/90 and quasi-isotropic laminates occurred along the tensile surface and involved both translaminar splitting and delamination. In contrast, failure of the 0-degree specimen occurred through the full specimen thickness with very little delamination. Failure of the +45/-45 specimen occurred without any identifiable conditions of fracture. This condition clearly illustrates the inadequacy of trying to characterize all flexural failures based on the appearance of 0-degree coupons as some authors have attempted.

As shown in figure 62, both the 0/90 and the quasi-isotropic laminates exhibited similar failure modes. Failure of these specimens typically involved the following characteristics:

- Translaminar tensile failure from the tensile loaded surface toward the specimens neutral axis.
- Extensive delamination of the plies located on the tensile side of the beam neutral axis.
